MISCELLANEOUS PAPER S-73-23

CONDITION SURVEY, MINOT AIR FORCE BASE, NORTH DAKOTA

April 1973

Conducted by U. S. Army Engineer Waterways Experiment Station
Soils and Pavements Laboratory
Vicksburg, Mississippi

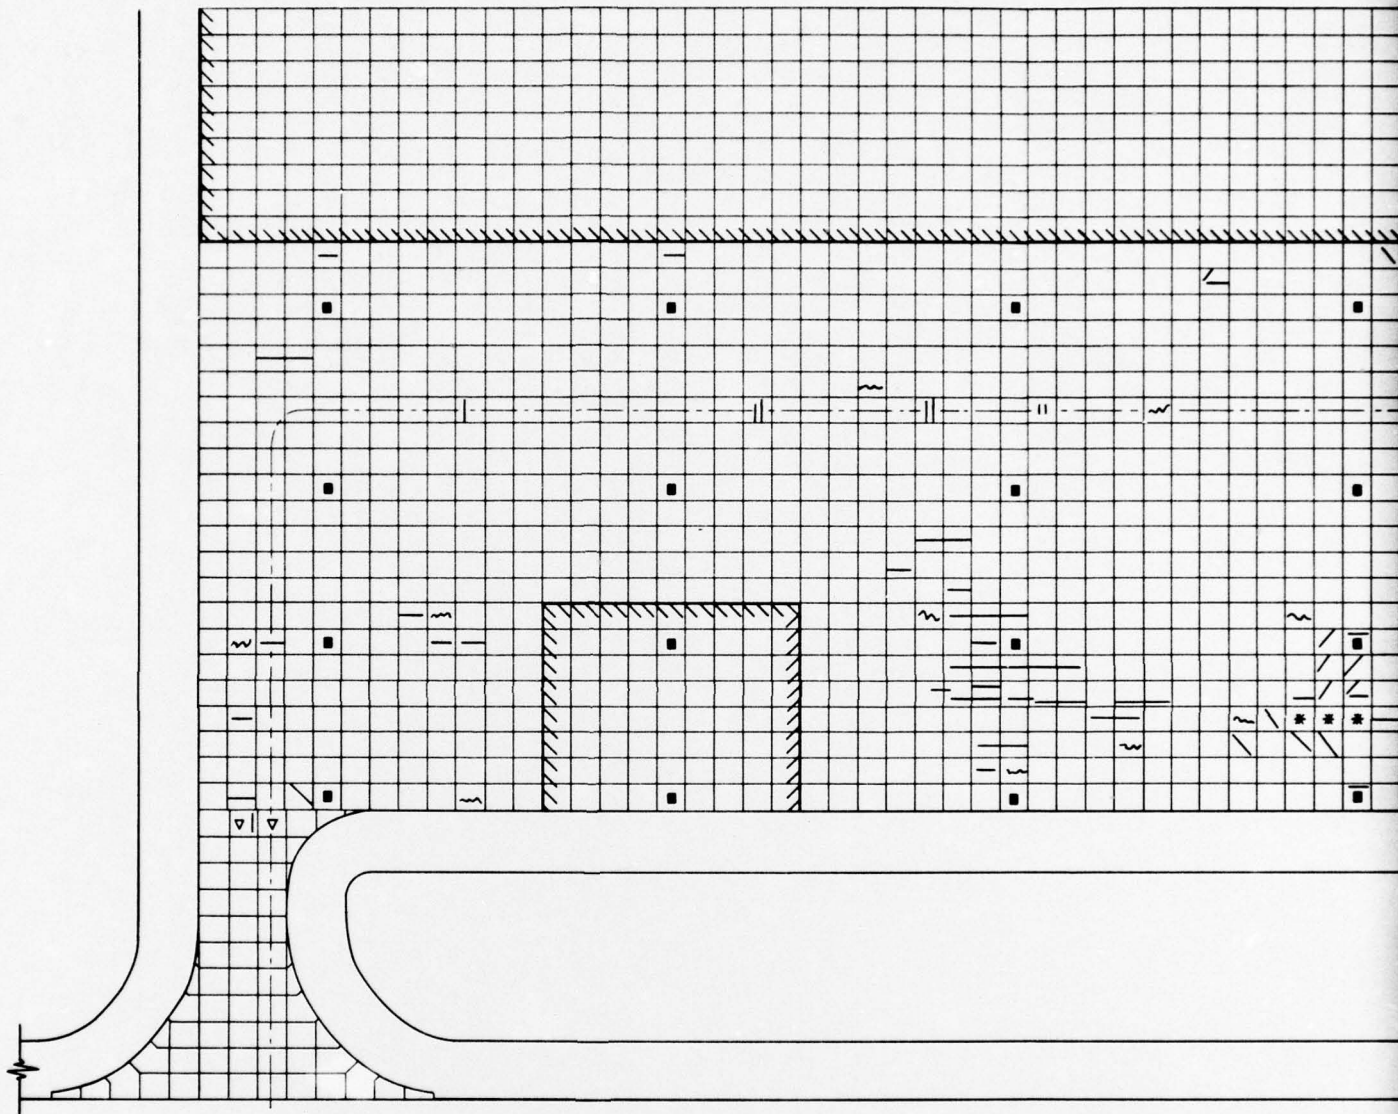
PLATE 4

contained shrinkage cracks and that the cracking was fairly evenly distributed over the four paving lanes. As is noted in plate 3, about 75 percent of the structural defects counted in 1972 occurred in slabs located in lanes 6 and 7.
